Smoke and Dye Testing Summary

High Level Sewershed

Run Summary

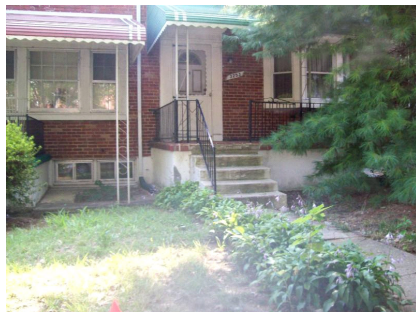
Picture \S1028-059-OB01-P01.jpg

Source Cleanout

Location Yard - front

Comments Smoke from cleanout in front yard. 3253 Yosemite Ave
